EROSION CONTROL BLANKET

ISSUED: 10/7/19	REVISED: 8/19/2020	DRAWING NO. 900-ECB-1
--------------------	-----------------------	--------------------------

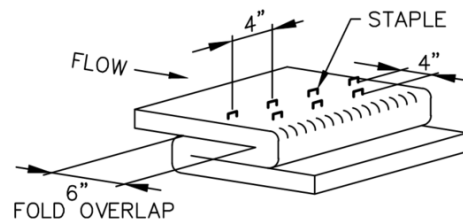
STAPLE CHECK
TO BE USED ON SLOPE EVERY 15 FEET
